Garmin software UPDATE PROCEDURE

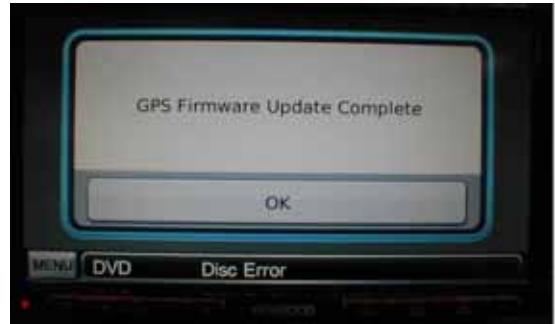
Symptom

1. Navigation screen freezes and the touch screen is unresponsive.
2. "GPS Firmware Update Complete" / "OK" is displayed for 5 seconds and reappears every 30 seconds.

For units experiencing the above symptoms, please perform the following update procedure.

1. First please update the Kenwood unit software from following Kenwood web-site before updating Garmin navigation software.
DNX7 series : after V.1.5.0
(DNX7000EX : after V.1.6.0)
DNX9 series : after V.1.7.0
<http://www.kenwood.com/cs/ce/mm/firmware/index.html>
