SERVICE ADVISORY

NO.: 1836 Rev A

TO: Vector 3 Customers
DATE: June 12, 2018
SUBJECT: Vector 3 Requires Hardware Inspection

Vector™ 3, Vector 3S

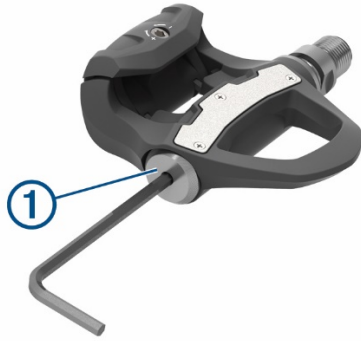
1. Before your next ride, check the torque of the spindle nut.
2. Use a 15 mm pedal wrench to remove the pedals.
NOTE: The left pedal spindle has a left-handed (reverse) thread attaching it to the crank arm.
3. Use a 4 mm hex key to remove the battery cover (1).

4. Set the battery cover and batteries (2) aside.
NOTE: Garmin recommends that all Vector 3 customers order the free, redesigned battery covers. For details, contact Garmin Product Support at support.garmin.com.

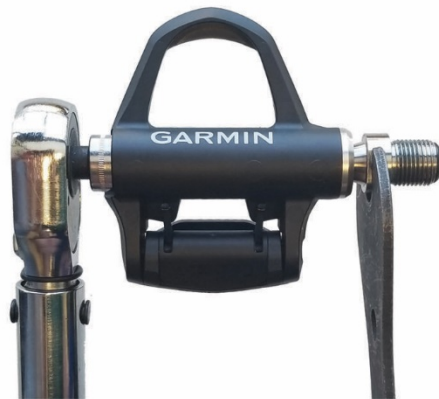
5. Use a small Phillips screwdriver (PH 00) to remove the two screws (3) from inside the battery carriage (4).
NOTE: If you have the Vector 3S system, the right pedal has no battery carriage.
6. Remove the battery carriage.
7. While securely holding the wrench flats with a pedal wrench, use the 12 mm socket wrench to torque the spindle nut (5) to 7 lbf-ft. (10 N-m).
NOTE: To ensure that the spindle nut stays in place, you must tighten it to the recommended torque specification.
NOTE: The right pedal has a black spindle nut and a reverse thread. The left pedal has a silver spindle nut. The left spindle has a line on the wrench flats.

8. Replace the battery carriage and two screws.
9. Replace the batteries and battery cover, and hand tighten it.
NOTE: Do not damage or lose the yellow O-ring gasket.

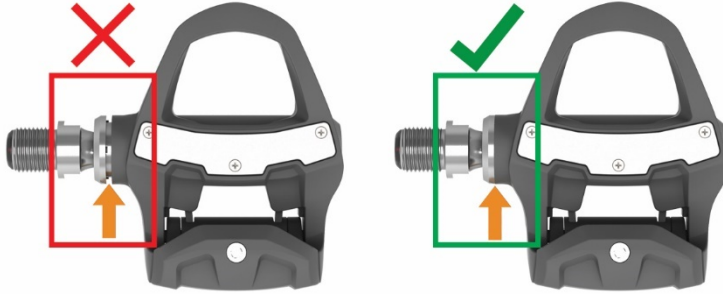
1. Examine the area where the pedal body connects to the cartridge.
If there is any separation between the pedal body and the cartridge, you could experience poor sensor performance, resets, or resistance to rotation.

2. If any separation is visible, contact Garmin Product Support at support.garmin.com.
